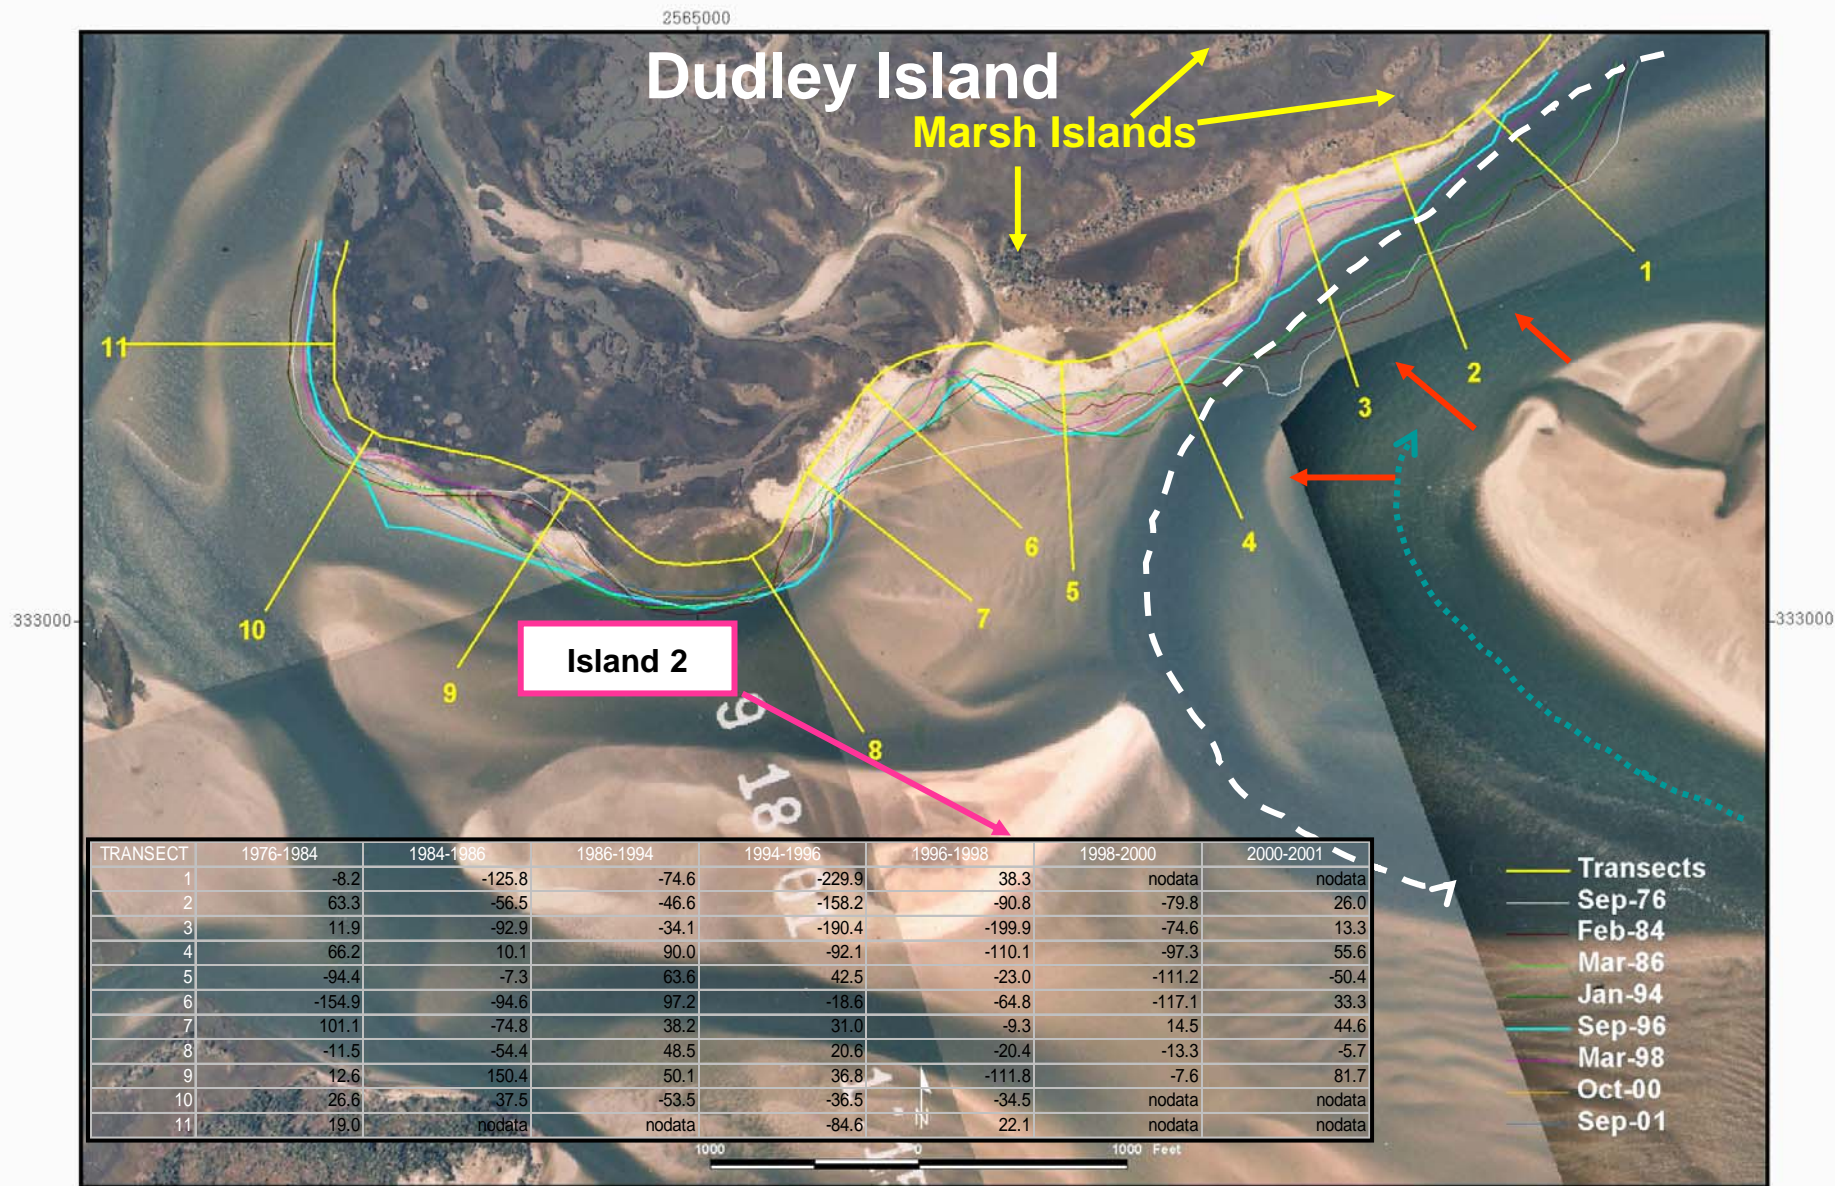
Figure 24. Enlarged aerial photograph of a portion of Dudley Island showing marsh shoreline transects and various shoreline positions between September 1976 and September 2001. Dashed line delineates axis of ebb channel while dotted line defines axis of marginal flood channel on the Bogue Banks shoulder. Table insert lists “shoreline” changes for transects 1-11.
